FHWA/IN/JTRP-98/15

Final Report

**METHODS OF CORROSION PROTECTION AND
DURABILITY OF CONCRETE BRIDGE DECKS
REINFORCED WITH EPOXY-COATED BARS –
PHASE I**

March 23, 1999

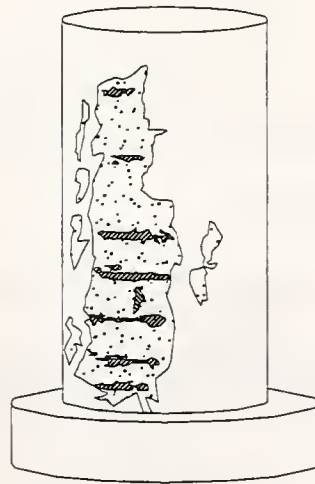
Figure 3.2 Typical Delamination Found on the Nile Channel Bridge in 1987¹¹

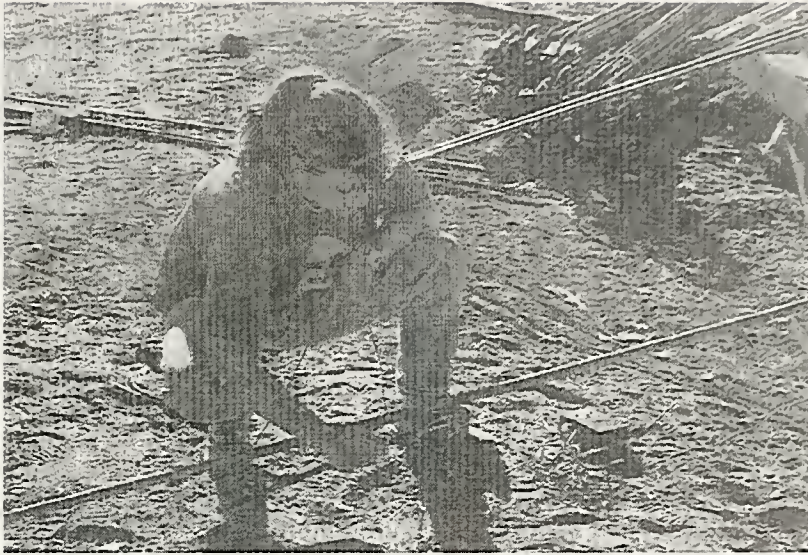
Figure 4.1 Holiday and Defect Testing after Arriving on Site

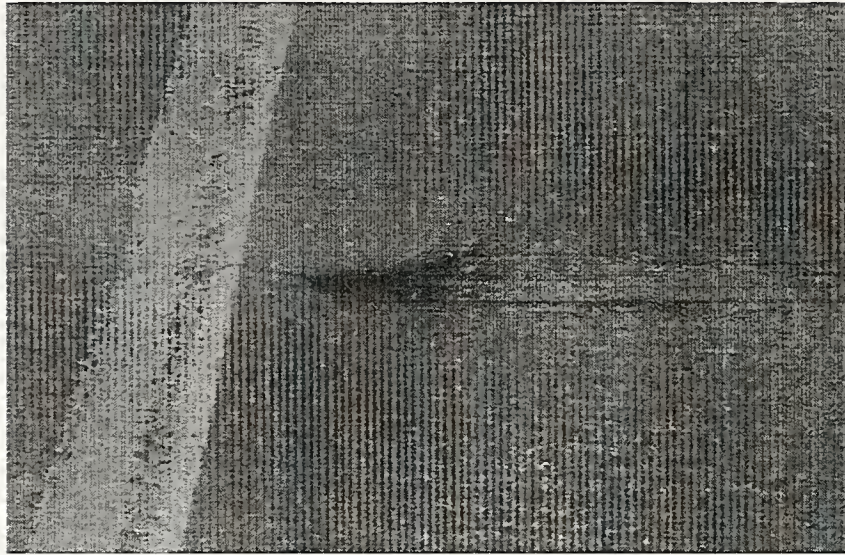
Figure 4.7 Rust Stain in Area of Cracking

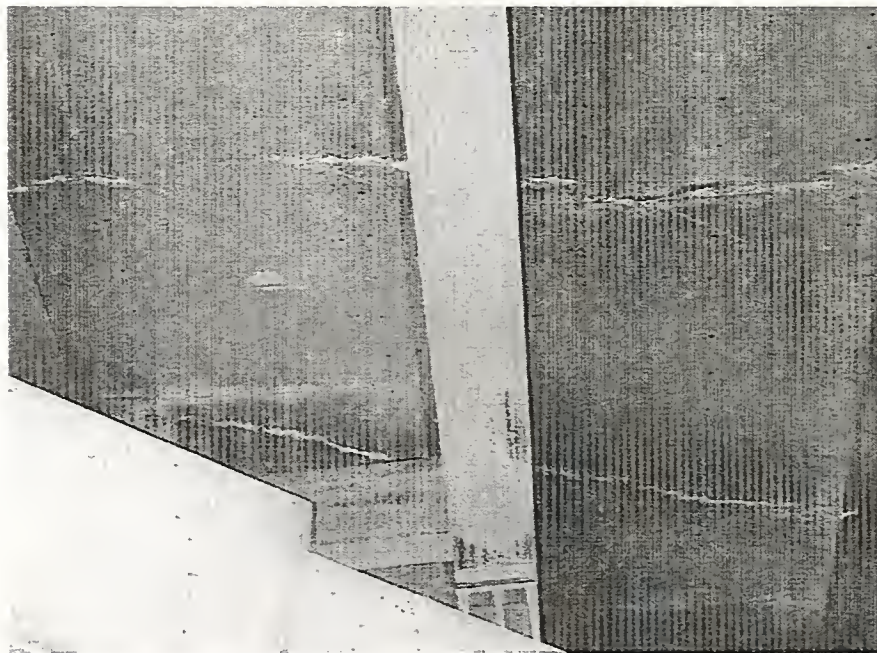
Figure 4.12 Cracking seen on Underside of Bridge Deck (Structure #37-47-5980)

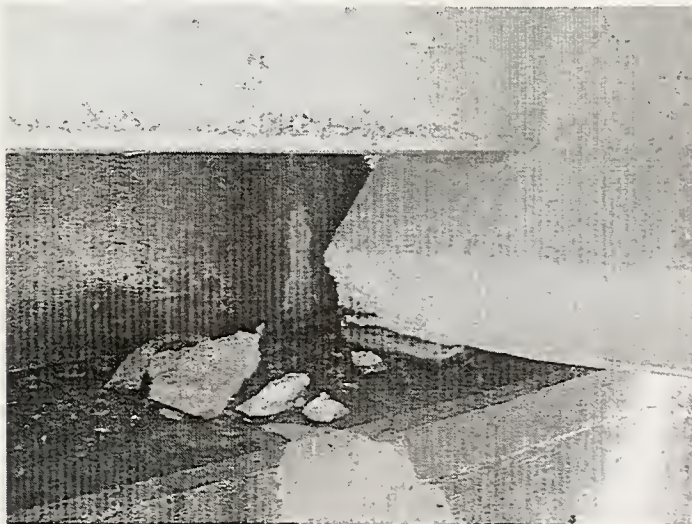
Figure 4.25 Corrosion Damage to Interior Prestressed Member (Structure #32-18-2182)

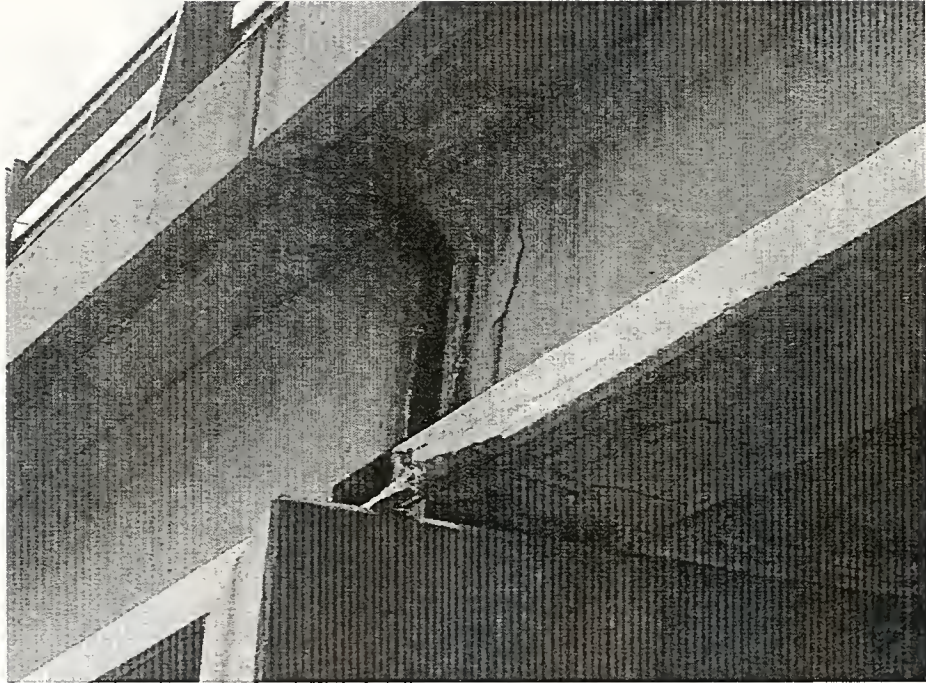
Figure 4.26 Damage to Exterior Prestressed I-Beam (Structure #32-18-2182)

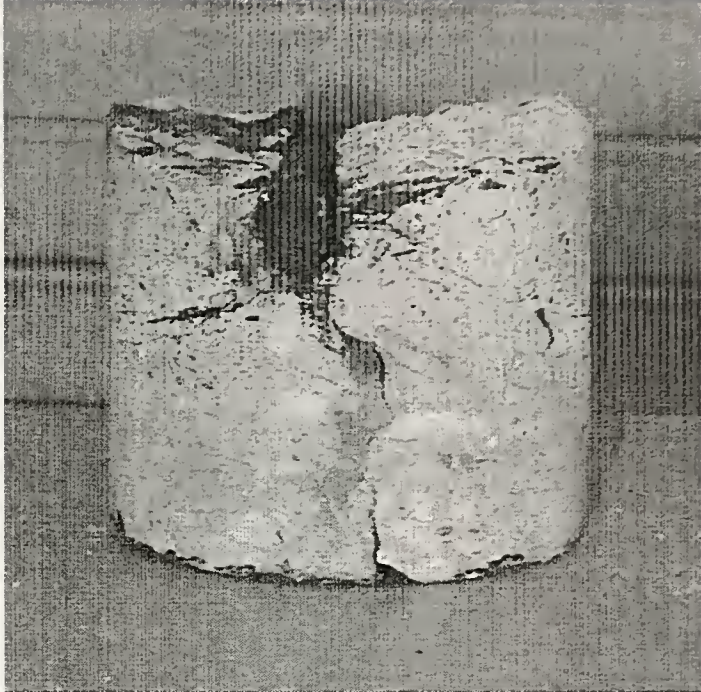
Figure 4.31 Core Taken in Cracked Area (Structure #6-50-5187)

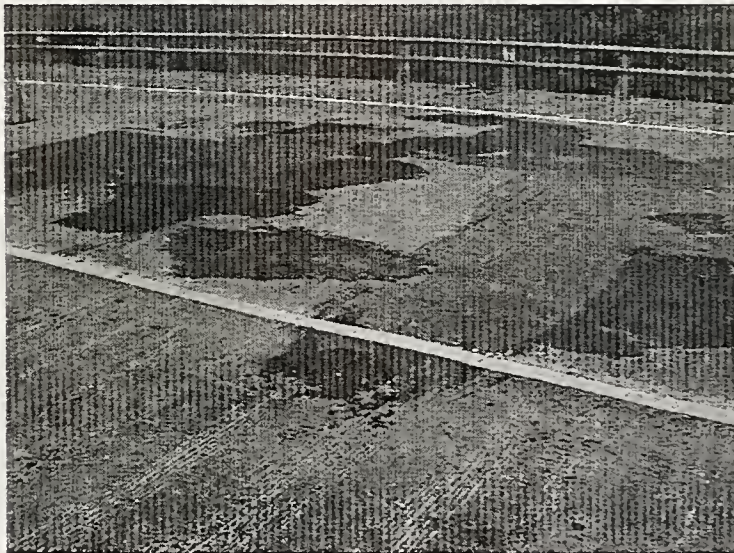
Figure 4.32 Extensive Patching of Bridge Deck (Structure #6-50-5187)

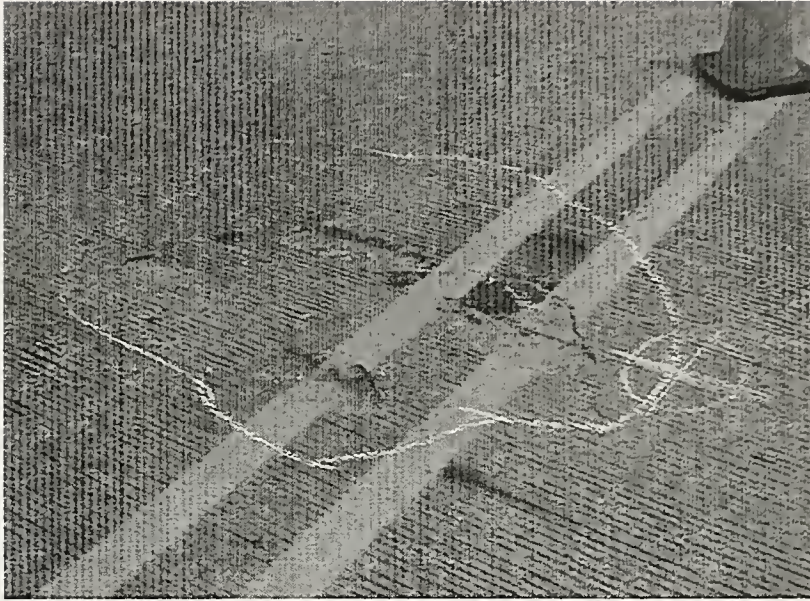
Figure 4.37 Delaminated Area with Spalls and Exposed Reinforcement
(Structure # 6-50-6624)

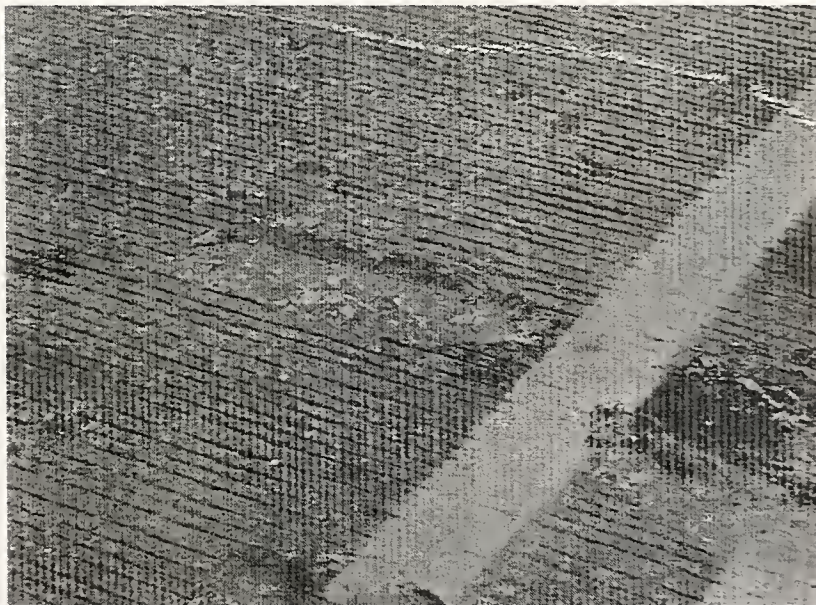
Figure 4.38 Exposed Rebar with Epoxy Coating Removed (Structure #6-50-6624)

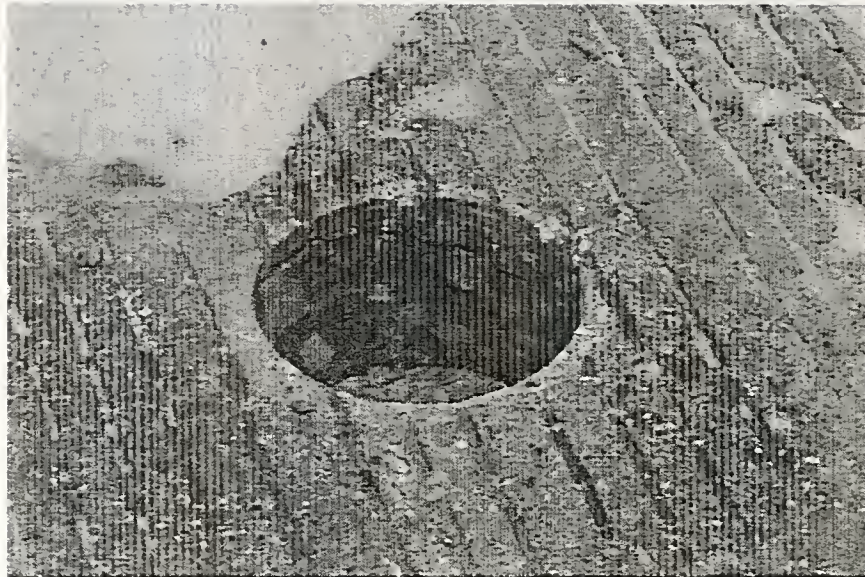
Figure 4.39 Delamination from Corrosion of Rebar (Structure #6-50-6624)

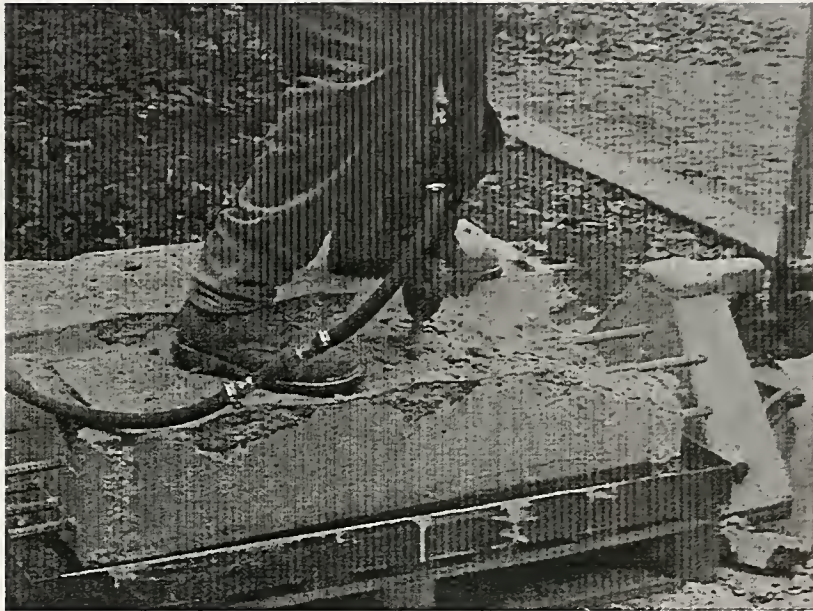
Figure 5.19 Removal of Reinforcement from Specimens
